Excursion guide

Sogndal-Byrkjelo
October, 20th 2023 8:00-16:00

by Thomas Scheiber, Paula Snook, Jens Tveit, Denise Rüter and Stein Bondevik

This excursion brings us to a number of localities where different landslide and avalanche deposits can be studied (Fig. 1). We will discuss both exogenic and endogenic processes that contributed to shaping the landscape of western Norway.

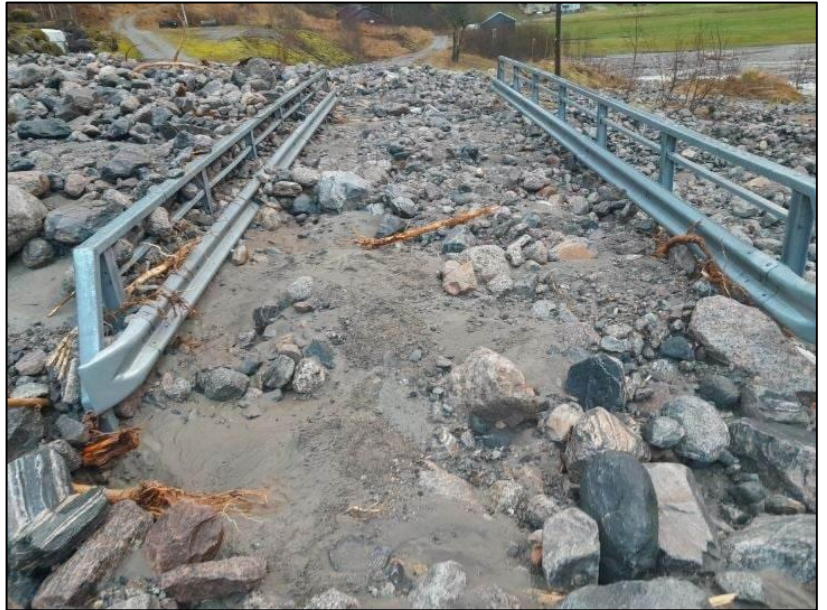
Fig. 8. Debris flow deposits from Nov. 12th 2022 (sognavis).

In November 2022, a rainstorm caused a sudden lake level rise and another spillover of the lake towards Tverrdalen with only little erosion at the 2004 breach. On November 12th, a debris flow from Tverrdalen again caused significant damage to the fields and the road along Supphelledalen, resulting in the isolation of the innermost farm (Fig. 8). If or to what extent the overflow of the lake has contributed to the triggering of the debris flow remains to be solved. The SKRED and BRE research groups at HVL have recently installed a time-lapse camera and a lake-level pressure sensor to monitor the lake level fluctuations at Flatbreen.

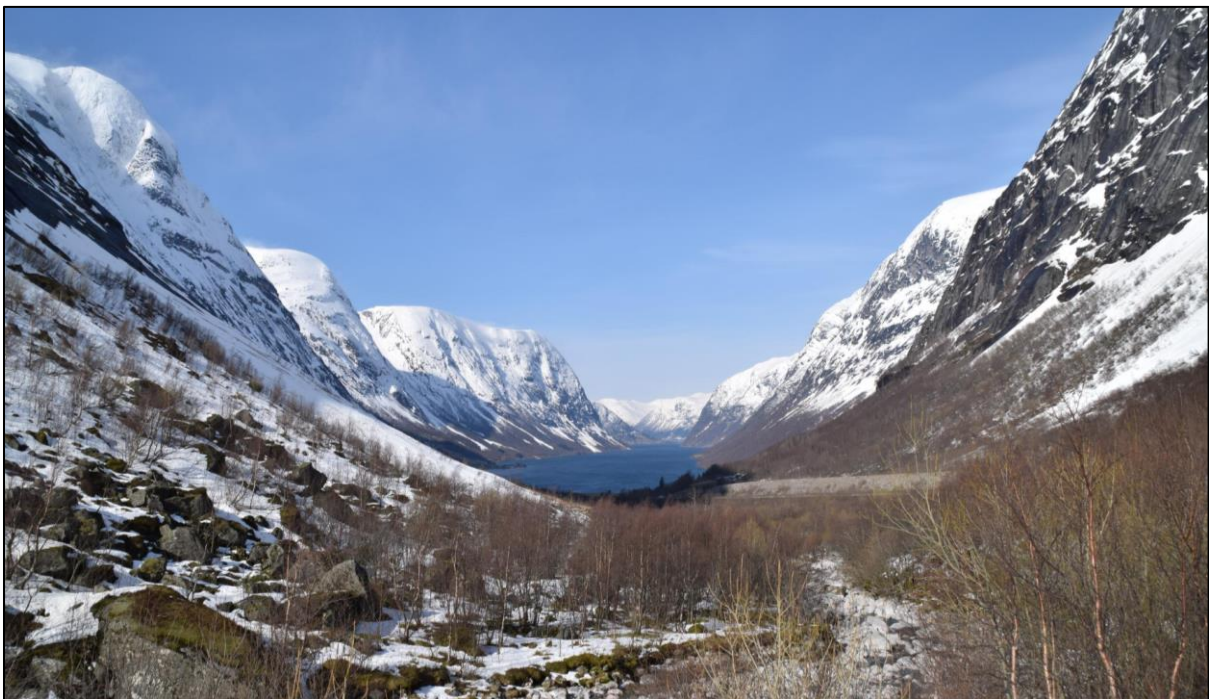
Fig. 9. View towards Kjøsnesfjorden (Picture: P. Snook)

This stop is situated directly at the western entrance of the Fjærlandstunnel. From this location we have a spectacular view down a glacially carved valley with landslide deposits along the slopes. The Kjøsnesfjorden lake level is at c. 200 m a.s.l. and the surrounding mountains are up to 1,600 m a.s.l. The mountain slopes are very steep and characterized by smooth slope-parallel rock slabs (Fig. 9) representing the surface expression of exfoliation fractures.

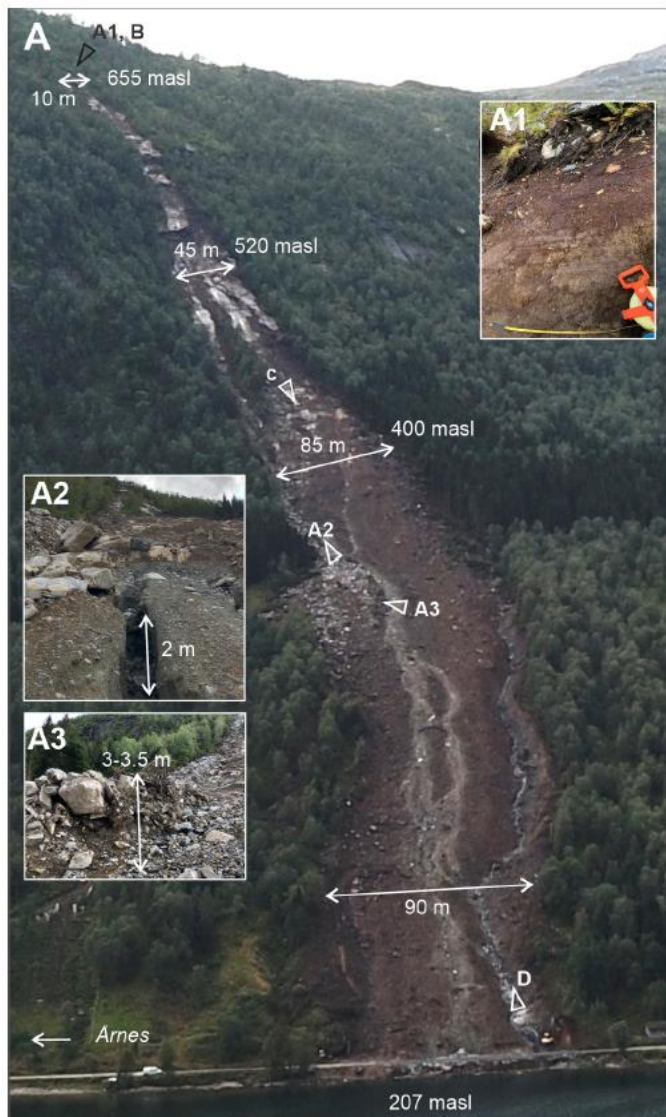
Fig. 13. Debris avalanche at Årnes (from R  ther et al., 2022)

120 debris floods, flows and avalanches were mapped in the Jølster area with 10 km radius around Vassenden (Fig. 12; Lindsay et al., 2022). The landslide events of July 30 caused extensive damage to public infrastructure and private property. One person died as the car was taken by a debris avalanche close to Årnes and swept into the lake Jølstravatnet (Fig. 13). We can still see the traces of this debris avalanche on the other side of lake Jølstravatnet.

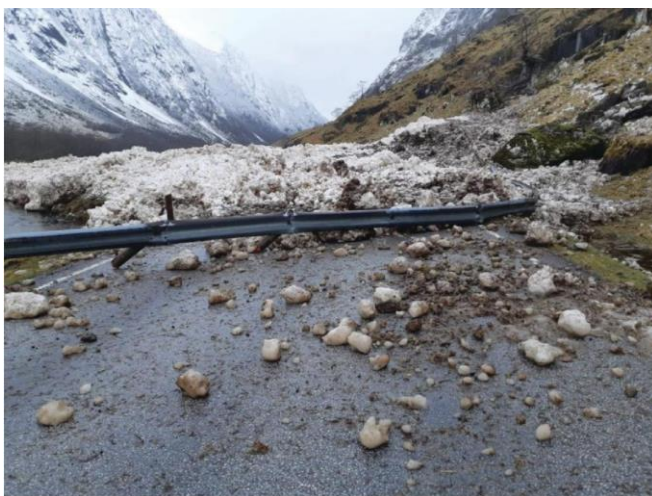
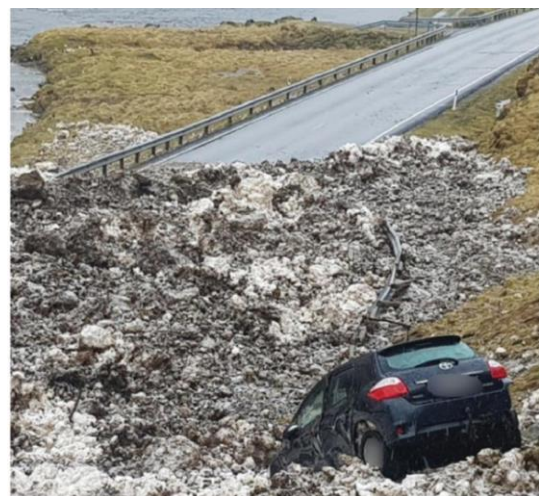
Fig. 15. Snow avalanche on Feb 21st, 2020. Pictures from NRK (left) and Bergens Tidene (right)

While rockfall dominates during summer times, the road through Votedalen is particularly exposed to snow avalanches during winter. There are several protection measures along the east side, such as dams along the road. However, most of the big avalanches come from the western valley flank. On February 21st, 2020, a snow avalanche from the western side of the valley crossed the road, which wasn't closed at this time. One car was taken by the snow masses and transported c. 30 meters up on the other valley side (Fig. 15). There are some «grey numbers» in registration of avalanches that affect the road since the events don't always cross the river. Still the powder cloud and air pressure can be of great harm to the traffic.
